Container, Underwater
Storage
EB 177A

PANEL

TESTS

This letter report summarizes the results of the inspection of the unpainted-metal test panels which were immersed in sea water at Daytona Beach, for 12 months, during the period from February, 1956, to April, 1957, in connection with Research Order No. 16. The four- and six-month inspection data on these panels were described in our letter report dated September 20, 1956.

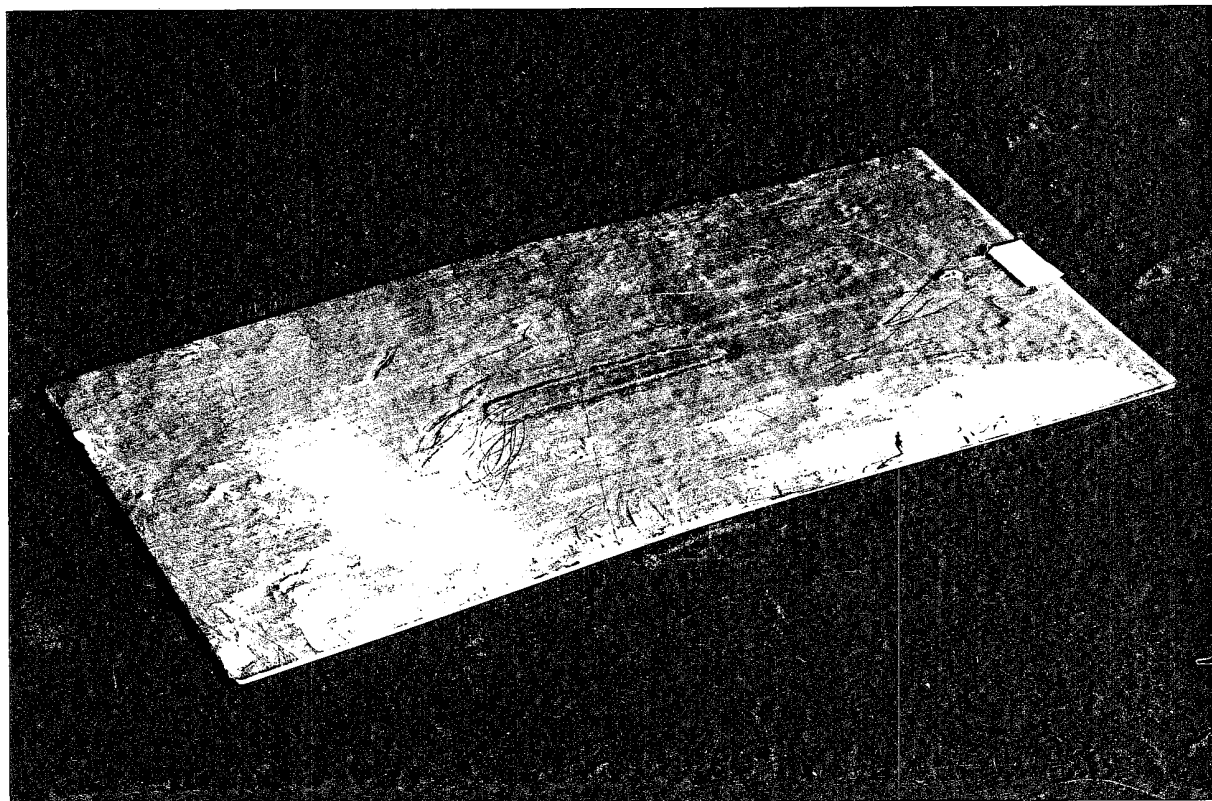
Figure 24. Back Side of Titanium Panel With Weld Bead
(No. 60W) - 12 Months of Sea-Water Immersion

No evidence of corrosion was noted.

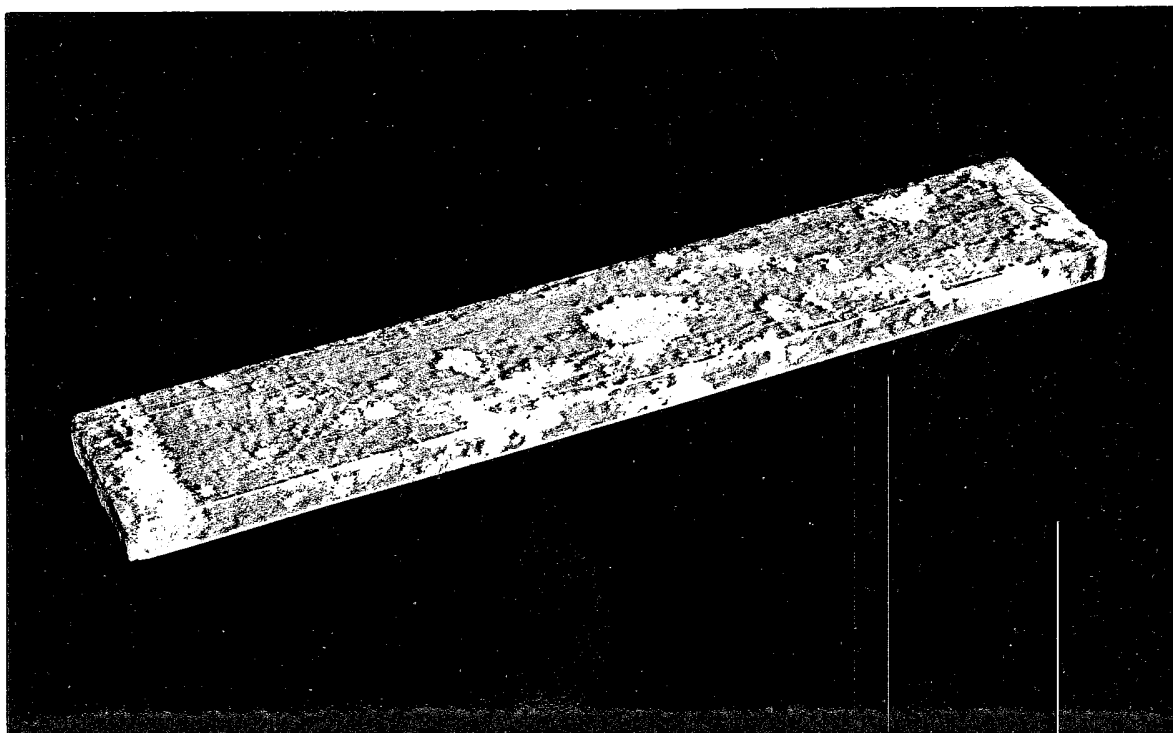
Figure 25. Cast Side of Cast Alloy 43 Panel -
12 Months of Sea-Water Immersion

Light areas show minor corrosion
damage. Pitting was very shallow.

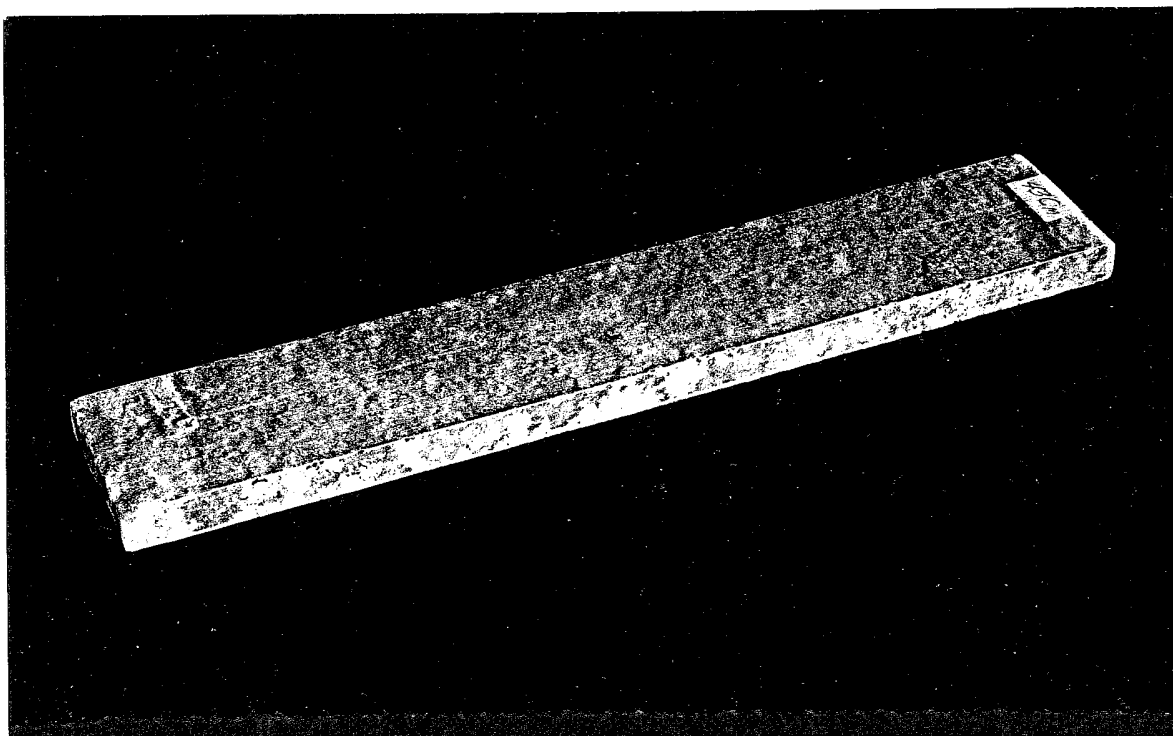
Figure 26. Machined Side of Cast Alloy 43 Panel -
12 Months of Sea-Water Immersion

Light areas show minor corrosion damage.
Pitting was very shallow.

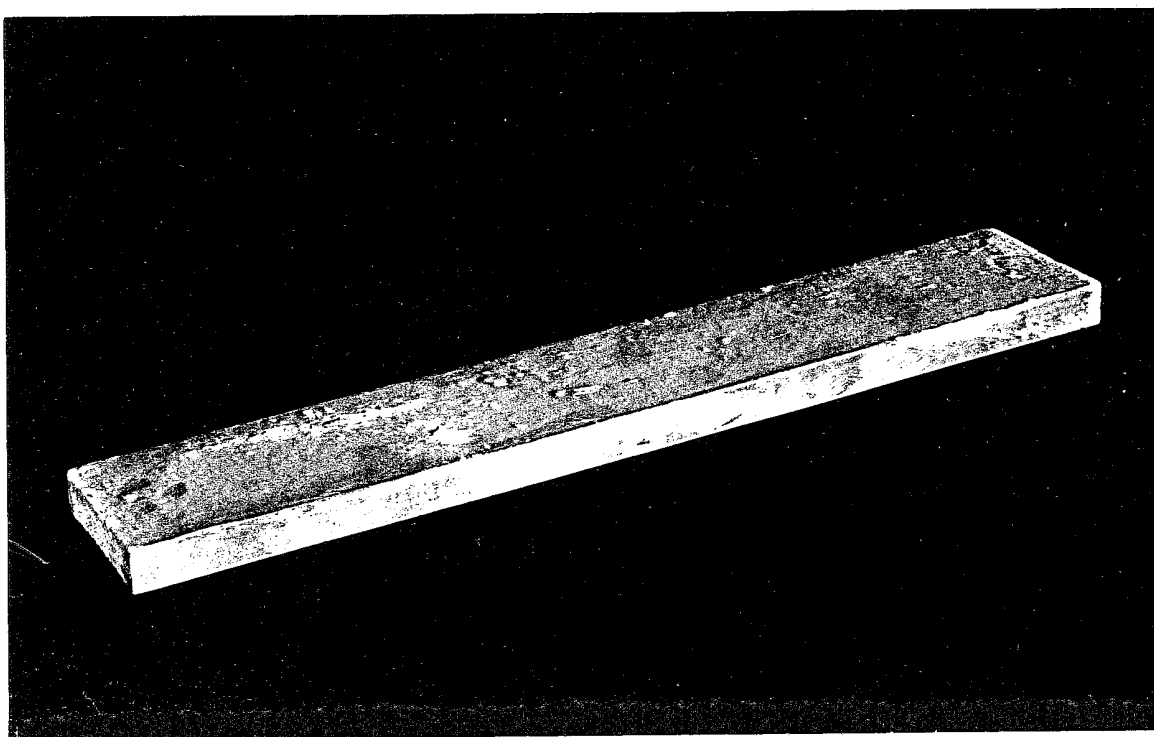
Figure 27. Cast Side of Alloy 356-T6 Panel -
12 Months of Sea-Water Immersion

Corrosion pitting was very light.

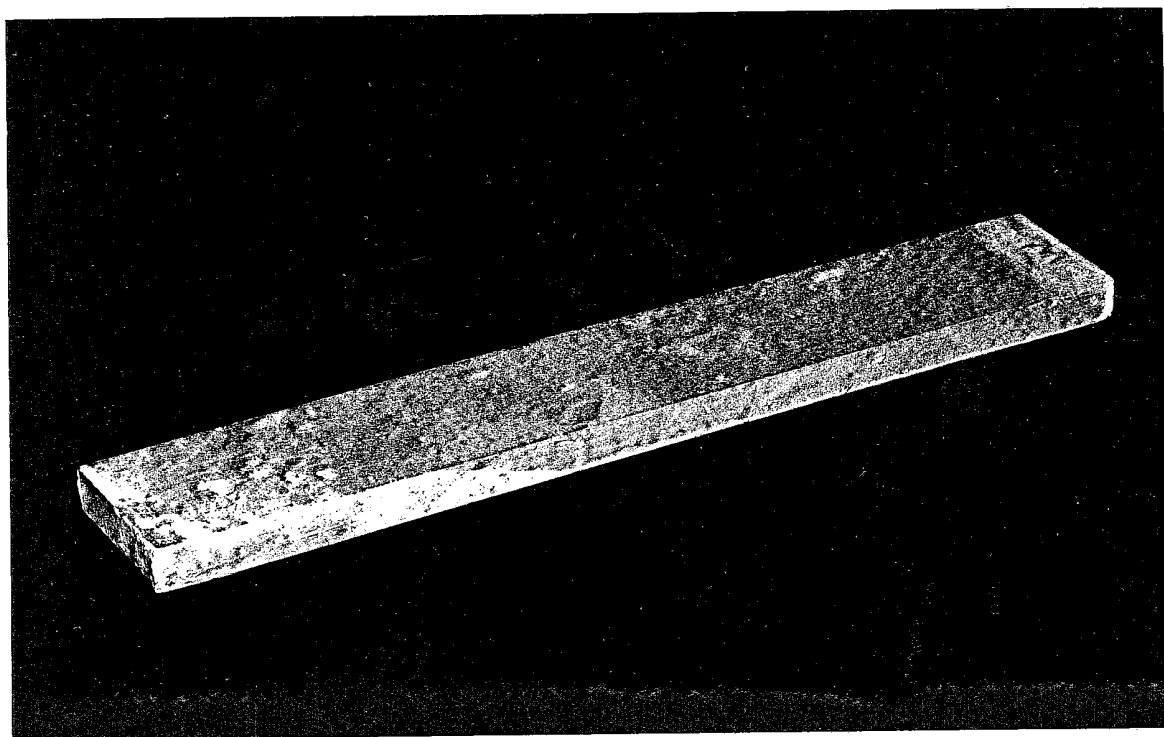
Figure 28. Machined Side of Alloy 356-T6 Panel -
12 Months of Sea-Water Immersion

-	356-T6	Only minor pitting.

Corrosion pitting was very light.
